# TOWNSHIP OF EAST FALLOWFIELD

## HISTORICAL COMMISSION

### MEETING AGENDA

APRIL 15, 2026

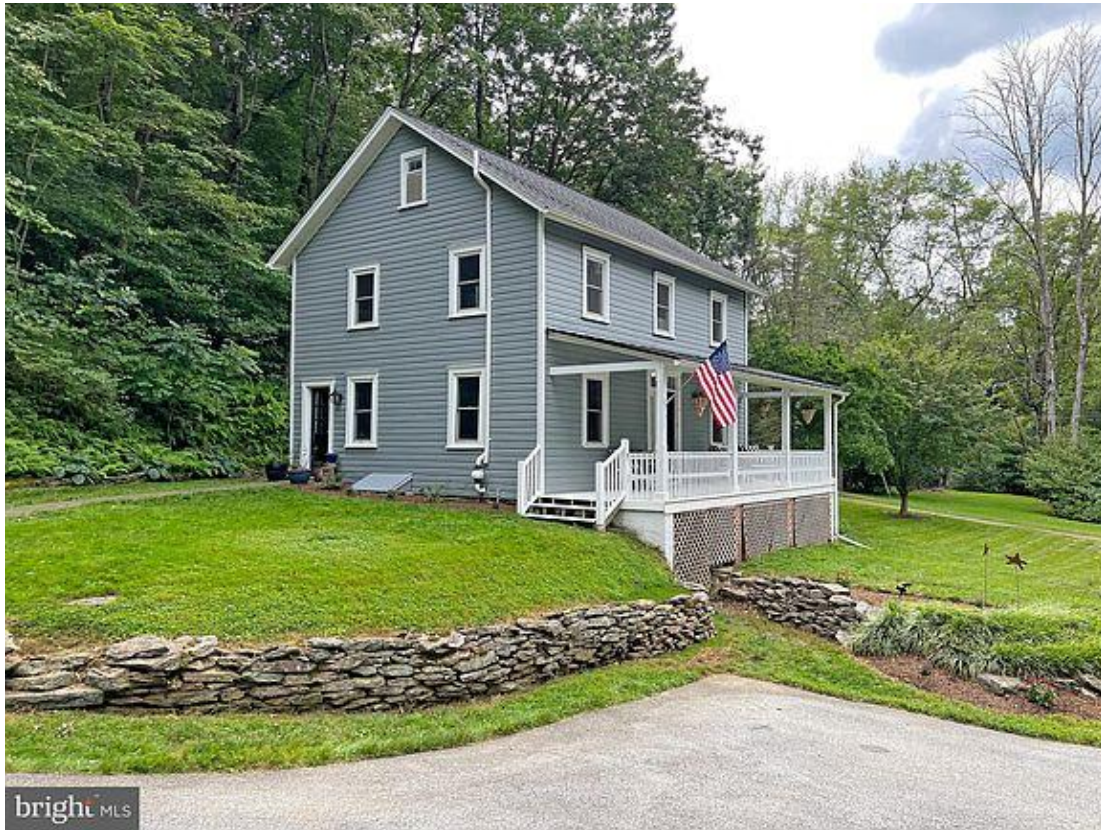
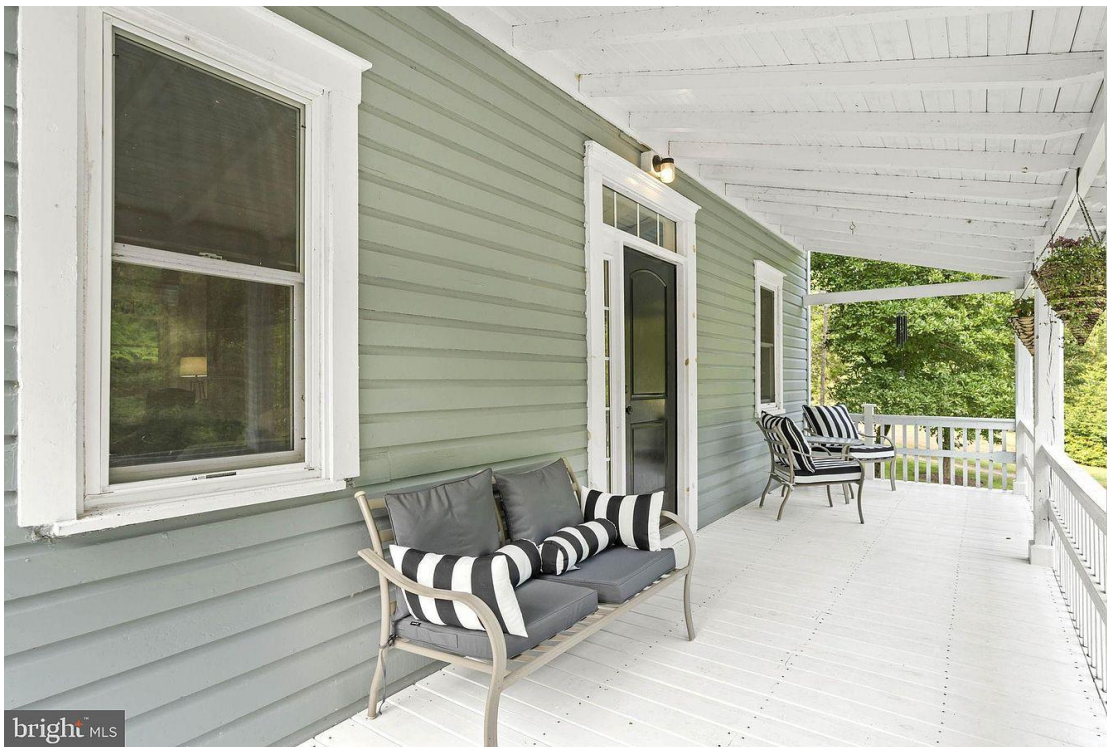
**Photos of 300 Glenrose Road (bright.MLS) – top is elevation view from street, bottom closer view of existing wood drop siding as existing on front of the structure**

- Owner, Jerry Lopez, is proposing to replace existing wood drop style siding with new siding due to termite damage at rear of structure. He proposes to use a lap siding product as manufactured by, and dropped off a sample of the siding for EFTHC review. A permit application has not as yet been filed with the Code Enforcement Officer.

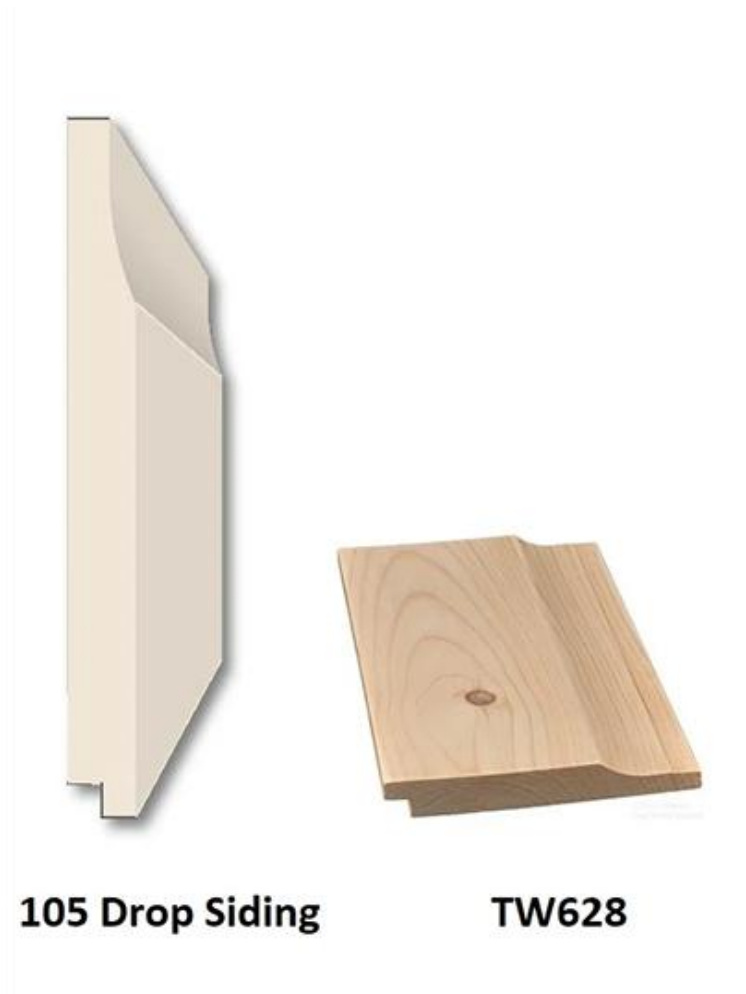
**ATTACHMENT – Typical Drop Siding Profile**

**Detail of drop siding profile similar to that presently existing at 300 Glenrose Road which the owner is proposing to replace. (product shown in illustration is a pine siding)**

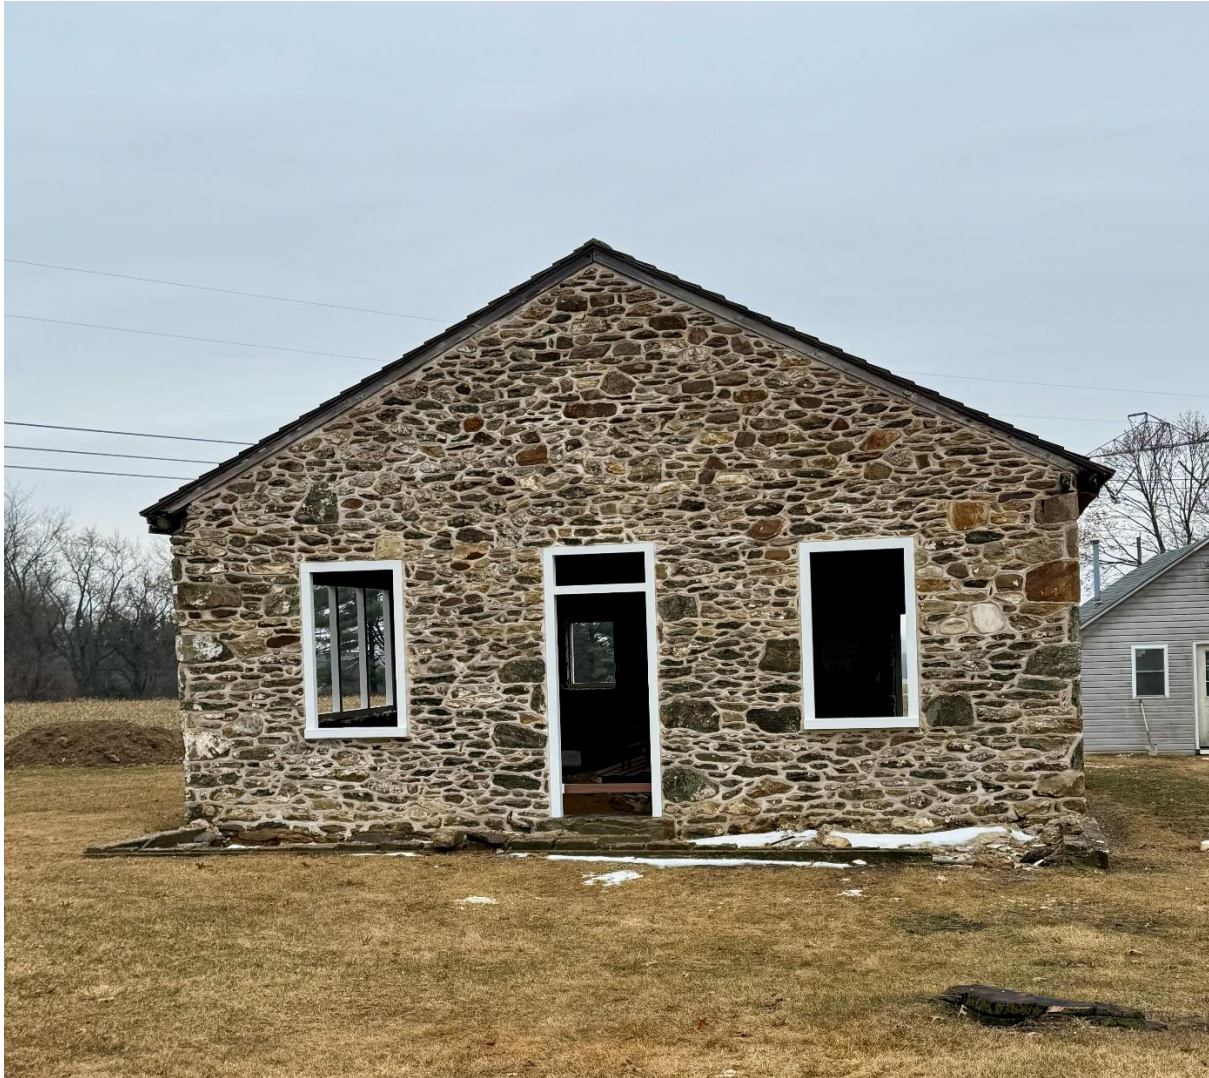
Photos indicate the existing conditions of the property as of 03-04-2026. By infrequent inspection of the status of the property, and comparison to photo survey in September of 2025, conditions are largely unchanged for a period of approximately six months, suggesting a willful abandonment of restoration activities, and a neglect of routine maintenance. The current conditions provide the potential for demolition by neglect, as window and door openings are open subjecting the property to intrusion and possible vandalism, and decay from the elements.

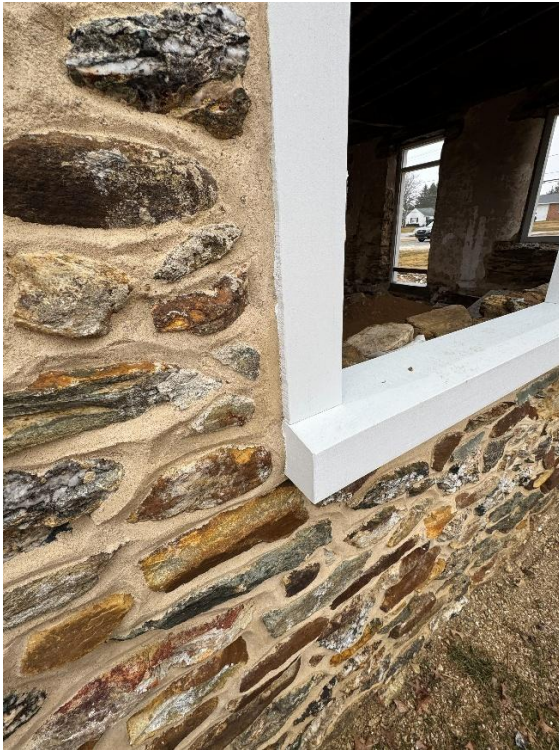
- Renovation started on the property in the summer and early fall months of 2025.
      1. It appears that a mason had started re-pointing the exterior masonry facade. Window rough openings were reworked, and window bucks were installed.

**AZEK WINDOW BUCK (TYPICAL)  
RE-POINTING OF MASONRY EXTERIOR**
